SUBJECT: Recommendation for replacement of Fabric Filter Bags

REPORT INTERMOUNTAIN POWER SERVICE CORPORATION

Reference: Unit 2 Bag Evaluations

Report Intermountain Power

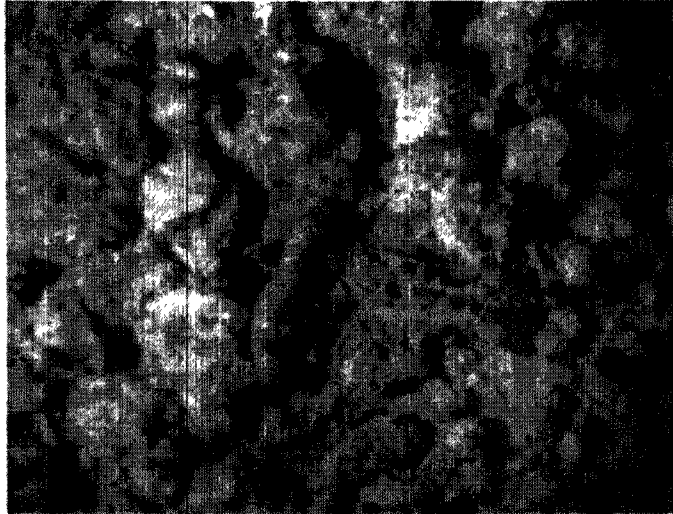
Examination of the ash cake revealed dust agglomeration generating reduced voids for the flow throughput.

Photo A and Photo B are microscopic views of the as received ash cake revealing the dense agglomerated ash with resulting low voids within the cake structure.

Extractions of the nodula revealed moisture induced hygroscopic sulphates as the binding force (calcium sulphate).

Moisture could be sourced from boiler tube leaks, dew point encounters and/or faulty soot blowing allowing condensation.

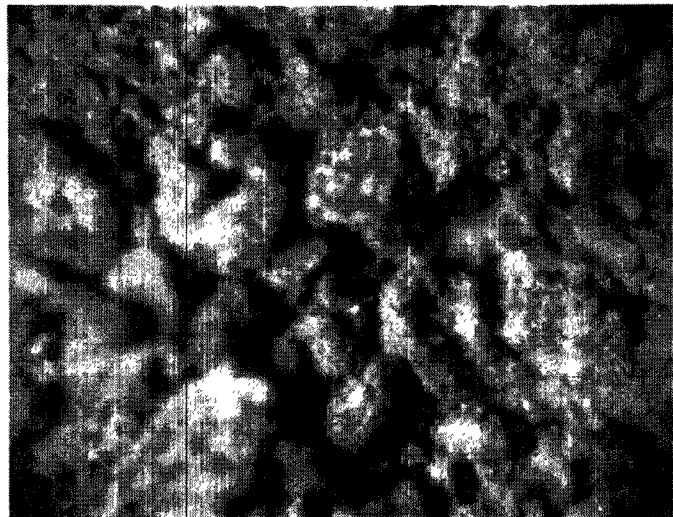
Photo B

Bag 1-A*-0-11 is at low flows/higher nodula than bag 1-A9-0-11 however both contain the agglomerated cake formation.

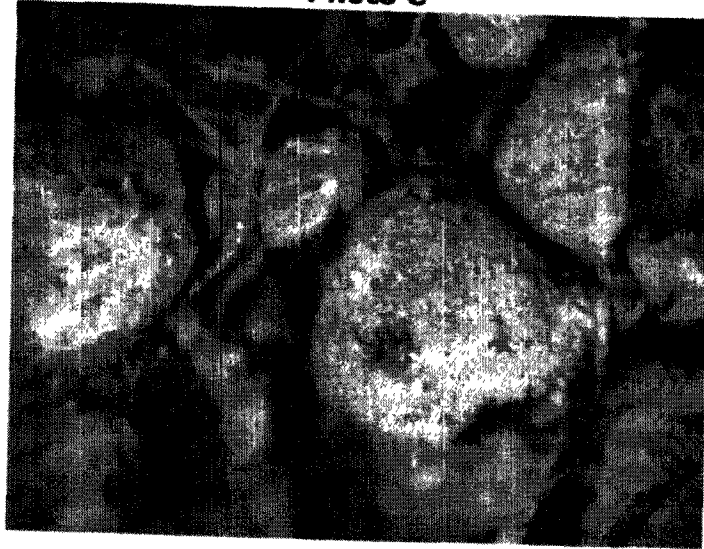
Photo C

The use of sonic assist will improve the level of discharge exhibited by these bags under RA flows only discharge is hampered from fiber encapsulation (Photo C).

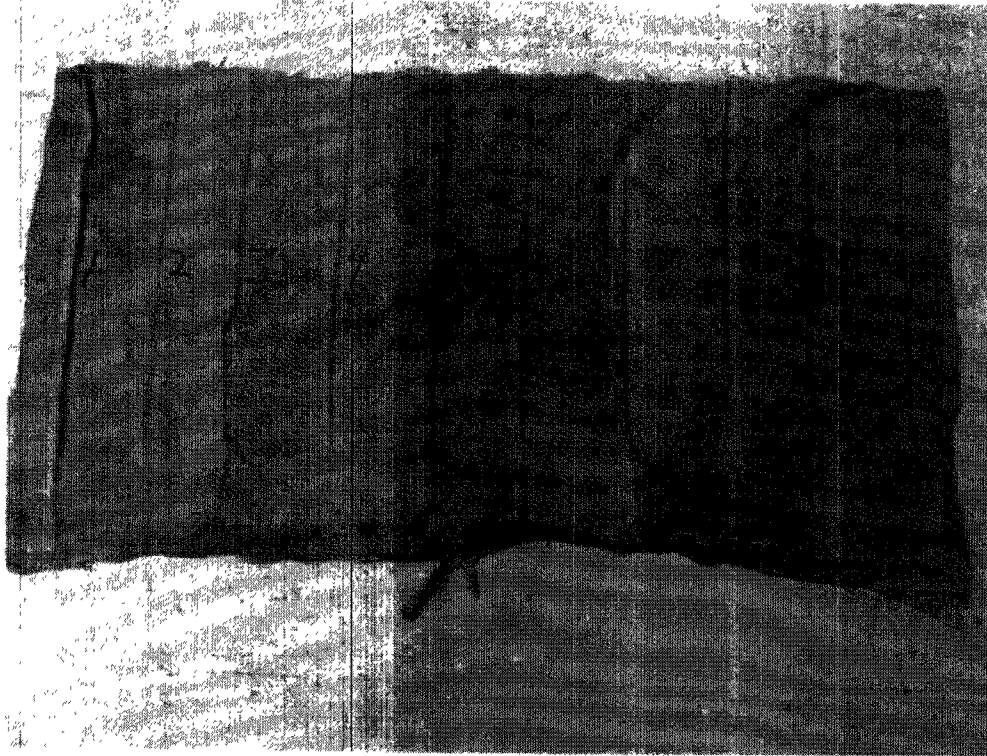
Both bags have good lines of collapse in full length indicative of good upward tension.

Photo D is a view of the lines of collapse common to both bags.

These vertical lines form under the reverse air/ collapse geometry of the bag into star shaped pattern.

With good specific line intensity and spacing around the circumference, good upward tensioning is indicated on the bags.

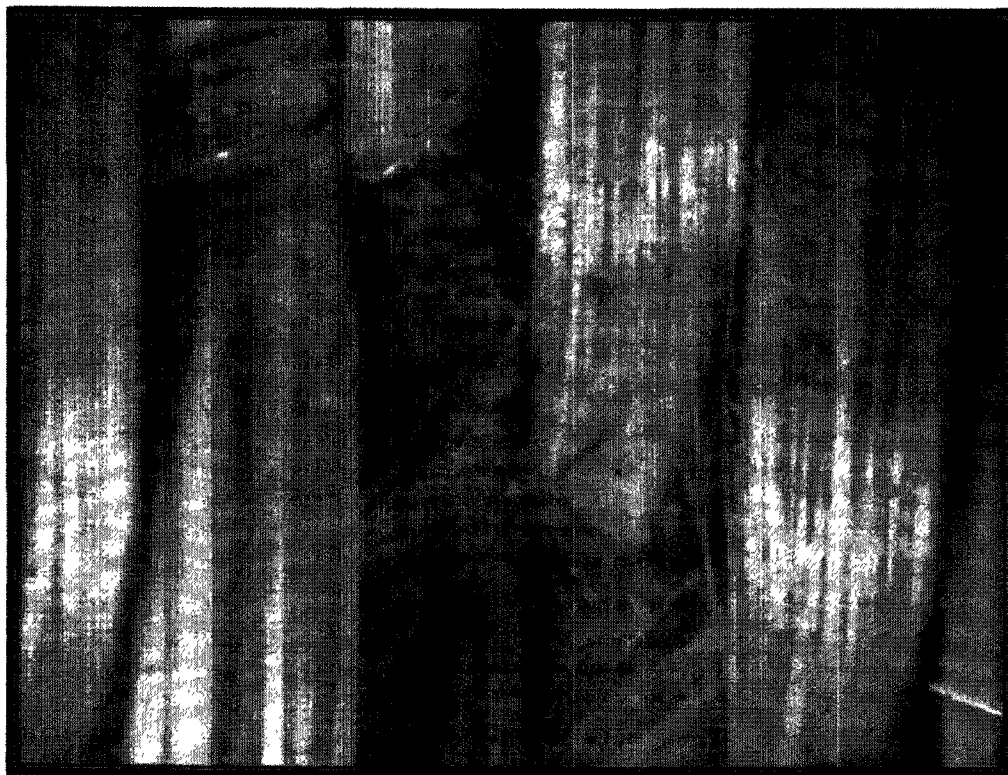
The media is at good ash collection characteristics with no significant fine micron dust penetration.

Photo C and D are views of the clean air side of the bags revealing very minimal levels of dust penetration.
